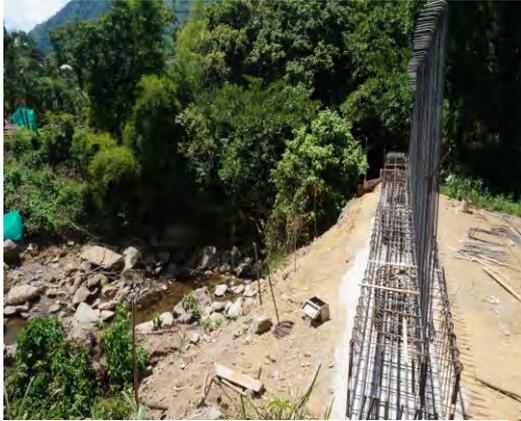
Picture 1 *La Ley* stream, K92+700, UF5. Lack of water protection barriers

11 Watercourse protection - sediment barriers, UF5 The Concessionaire needs to improve the sediment barriers in UF5 in K82+355 and K92+700 (La Ley stream)	July 2017	New Action

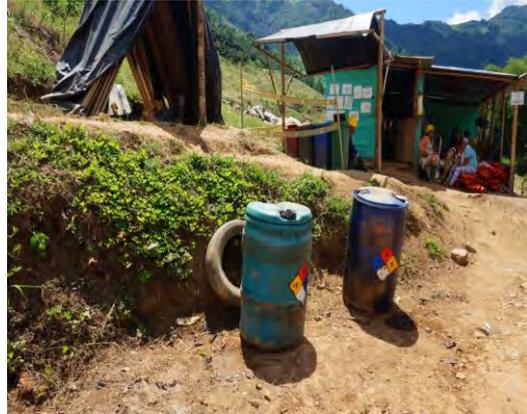
Picture 2 Improper handling of hazardous materials

Proposed Action (As set in the ESDD)	Proposed Deadline	Current Status (Updated June 2017)	Color code
flow, which was estimated to be between 0.0-3.0 l/s. Up to date, the Concessionaire is not complying with the water treatment system established in the license modification (Resolution 0061, January 2017)			
8 Hazardous materials management, Exit portal Tesalia Tunnel, UF2 The Concessionaire should improve the ACPM supply at the exit portal of Tesalia Tunnel with an additional protective barrier.	July 2017	New Action

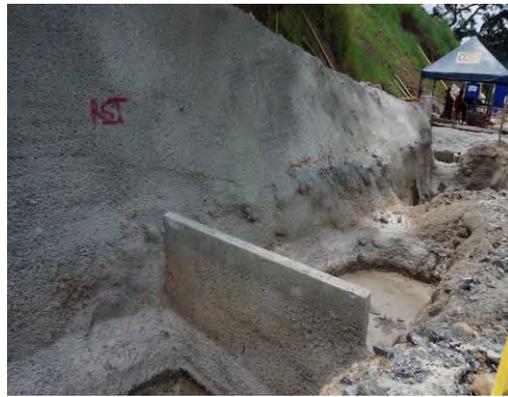
<p>7 Industrial water treatment system – Exit Portal -Irira Tunnel</p> <p>Despite the Concessionaire has a temporary sedimentation system at the exit portal, it could be improved. In Arup’s opinion, the Concessionaire needs to implement a permanent primary treatment, capable to attend the infiltration</p>	September 2017	New Action

Picture 4 Improper industrial water treatment system

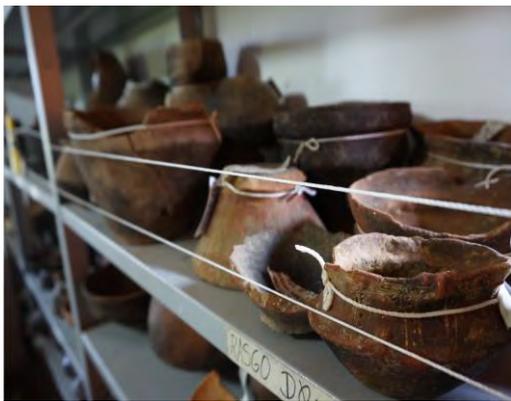
Picture 5 Archaeological laboratory

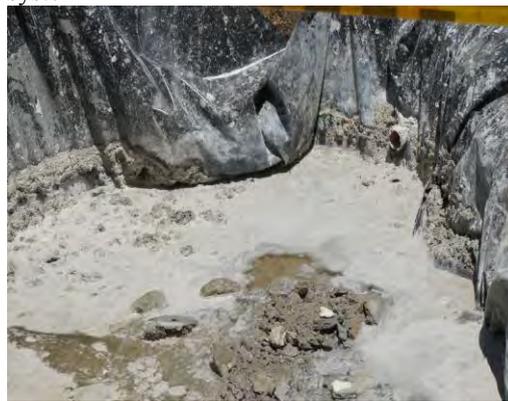
10 Concrete launcher water treatment – Entrance portal Tesalia Tunnel, UF2 The Concessionaire should intensify the maintenance of the sedimentary pools for the waste water of the concrete launcher at the entrance portal of Tesalia Tunnel, UF2. During the site visit, it was evidenced that the pools had a lot of sediments, representing a possible risk of pollution	July 2017	New Action

Picture 6 Concrete launcher water treatment, UF2

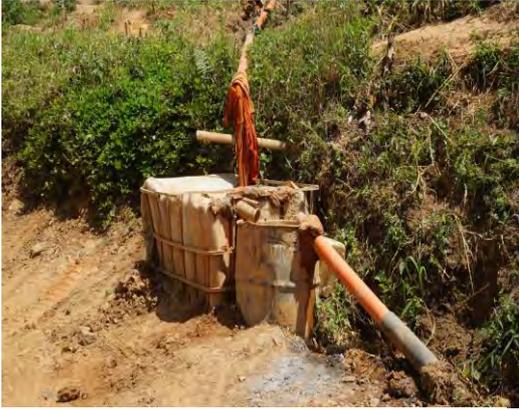
Picture 7 Inadequate waste water system, exit portal - Tesalia Tunnel

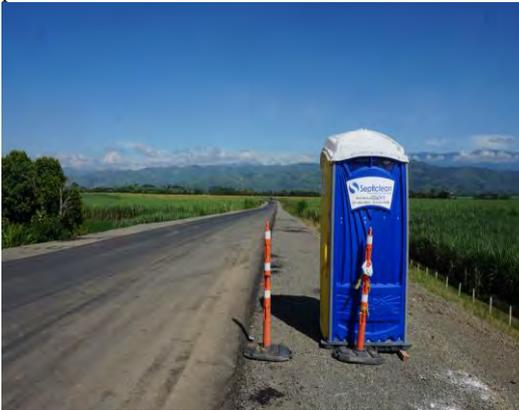
Picture 9 Portable toilets in UF1

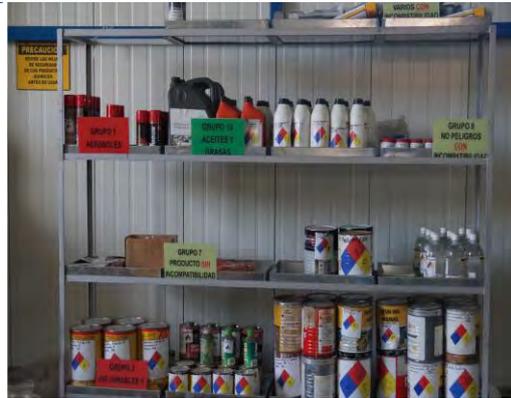
Picture 10 Storage of hazardous materials
