## 6.2 Action Plan

## 7 General Recommendations

## 8 Photographic Record

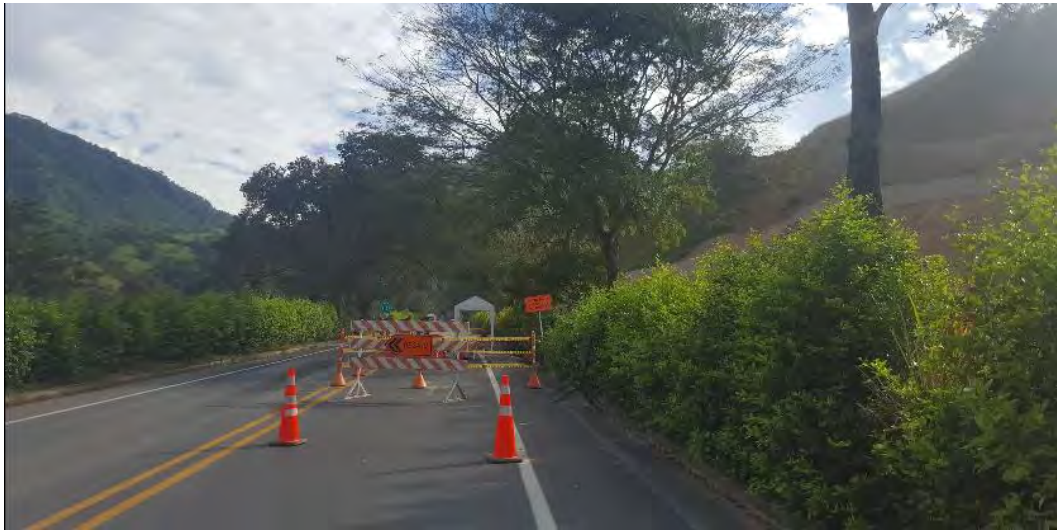
Image 3 Road signalling

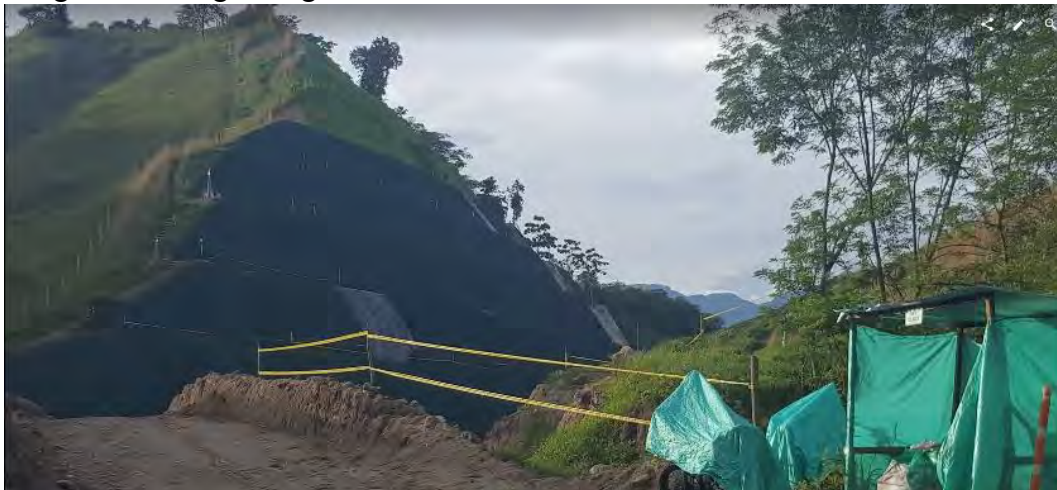
Image 4 Adequate planting of vegetation cover in slopes

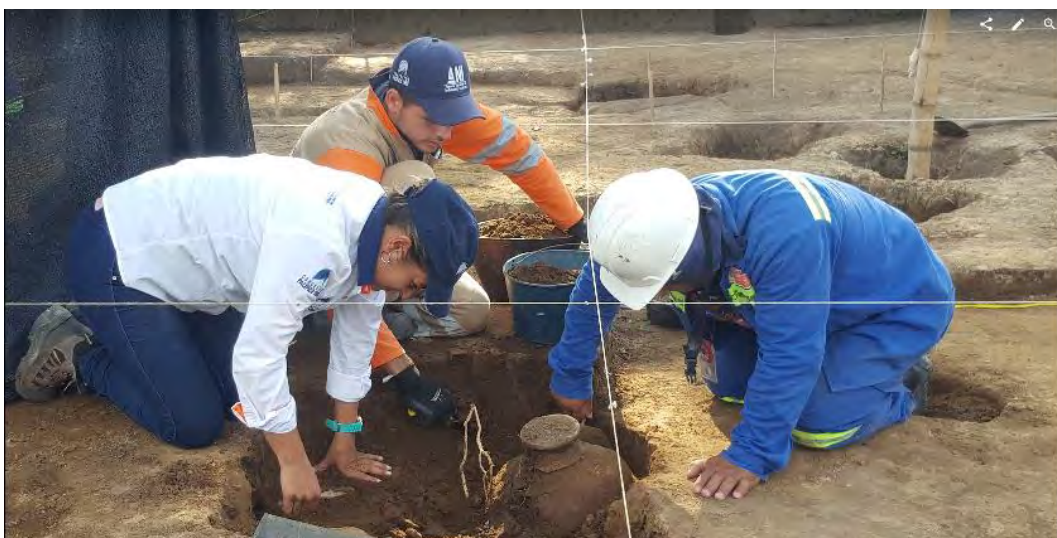
Image 5 Archaeological rescues

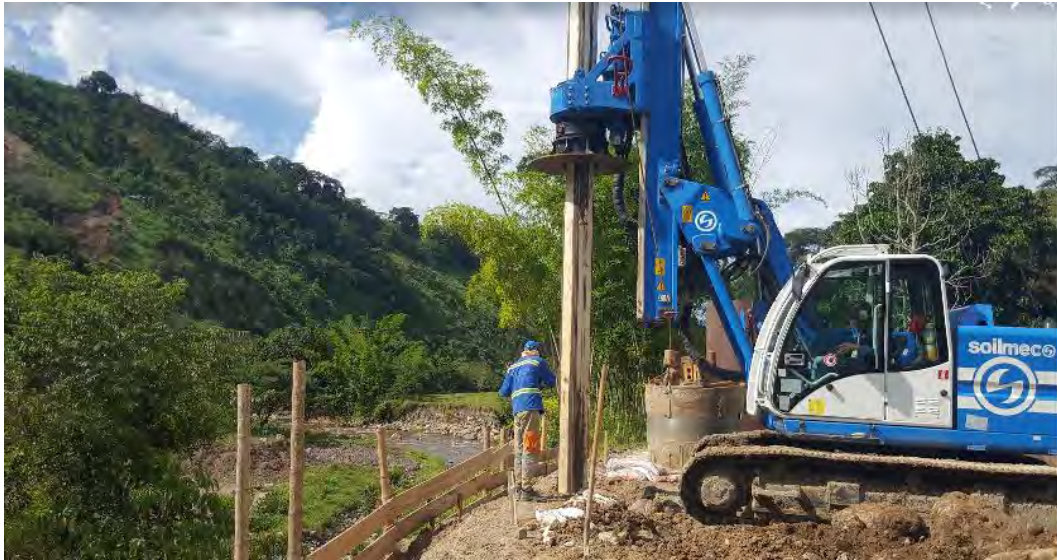
Image 6 Adequate water course protection

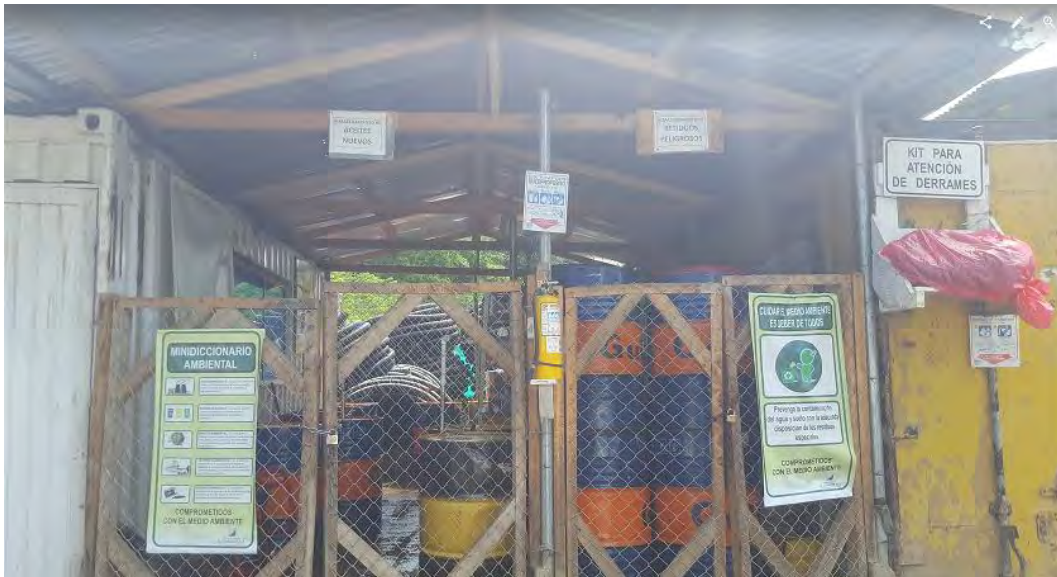
Image 7 Storage of dangerous materials

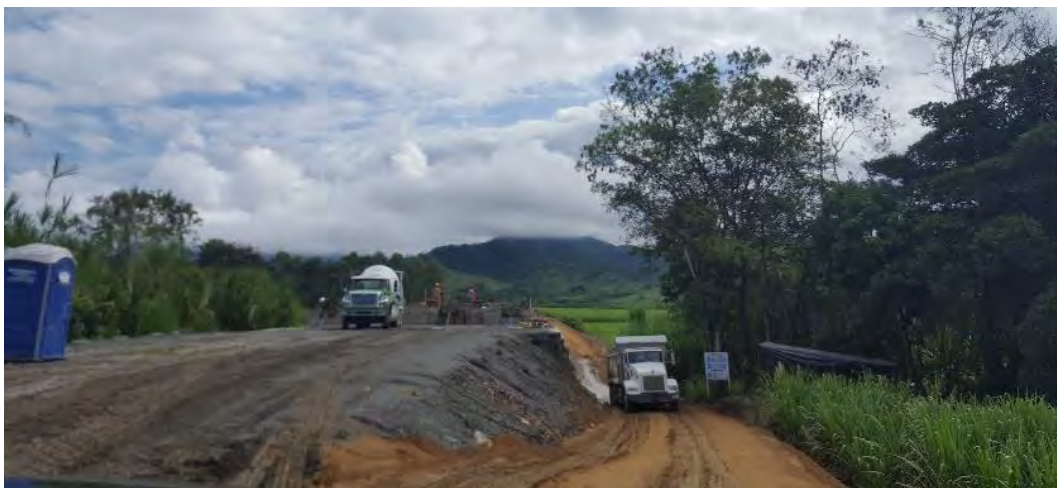
Image 8 Earthworks in UF1
