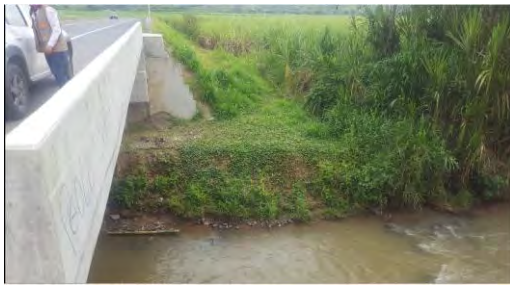
<p>8 Watercourse protection – Risaralda and Totuy river banks, UF1 The Concessionaire is obliged to recover the Risaralda and Totuy river banks in UF1 due to the bridges construction in this sector. The bridges are already finished and the Concessionaire should begin recovery activities</p>	July 2017	The Concessionaire finished construction works in Risaralda and Totuy bridges. During the site visit, it was evidenced an adequate recovery of the surrounding area. See Figure 1

Figure 1 Totuy River, recovery of river banks

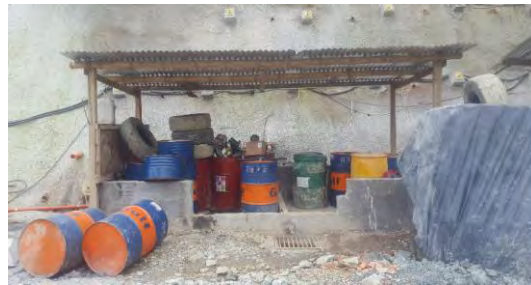
<p>7 Hazardous materials management, Exit portal Tesalia Tunnel, UF2 The Concessionaire should improve the ACPM supply at the exit portal of Tesalia Tunnel with an additional protective barrier.</p>	Immediately	During the site visit, Arup evidenced that the hazardous materials management still needs to be improved. The storage room is under its capacity and there is a risk of spills and soil contamination.

Figure 2 Overcapacity storage of hazardous materials

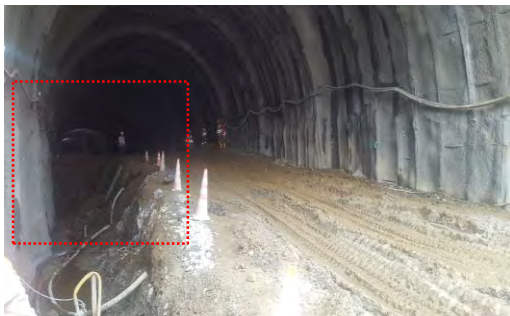
14 Risk of fall at Tesalia Tunnel (Entrance portal) The channel to conduct the water from inside the tunnel to the its entrance, is not well signaled and does not have any protection barrier. This could represent a risk of fall for employees and machinery. UF: 2.2 PS4	Immediately	New Action

Figure 3 Risk of falling at the entrance of Tesalia Tunnel. Lack of signalling and protection barrier.

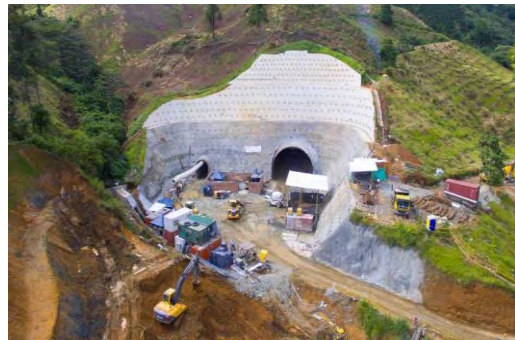
Figure 4 Exit portal of the *La Tesalia* Tunnel

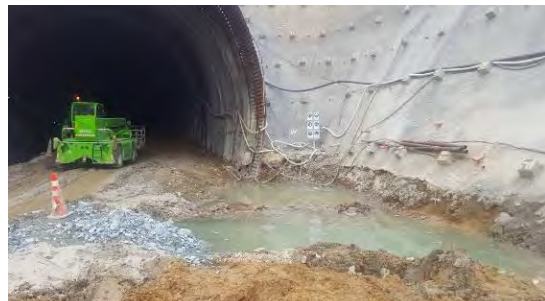
<p>17 Industrial water management of Tesalia Tunnel: The Concessionaire has started construction activities in both tunnels and has implemented a permanet primary treatment, which currently is capable to attend the infiltration flow. However, the water conduction from inside the tunnel to the treatment system could be improved. Specifically, in the entrance portal of Tesalia Tunnel, there is a lot of stagnant water (Figure 8). UF2 PS3</p>	Inmediatly	New Action

Figure 8 Tesalia Tunnel Entrance
