7.4 Compliance with Supervision Monitoring

8 Photographic Record

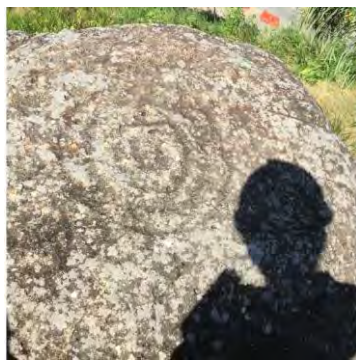
No.	Proposed Action (As set in the ESDD or previous Action Plan)	Proposed Deadline	Current Status (Updated December 2018)	Color code
3	<p>UF: 5 PS/EP:PS5</p> <p>Archaeology: According to the results obtained during the archeological field studies phase, which determined that the Project area has an archeological potential qualified as medium-high, and estimated the probability of archeological findings, the area is considered to have a risk of significant findings.</p> <p>In Arup’s opinion, the Concessionaire is making efforts in advance with the archeological rescues and is having a responsible management of archeological findings.</p> <p>However, Arup evidence that the Concessionaire has not find all the required final places in which the rescued archeological material will be delivered. The Concessionaire should submit in the following period the selected places.</p> <p>Regarding Cafetales and the Petroglyph Arup request to be informed about the process and risk of delay in the construction activities.</p> <p>UF: All PS/EP:PS8</p>	<p>Biannual – Next Envi. And social report.</p>	<p>During the reported period the Concessionaire carried out archaeological monitoring activities in Zodmes, UF 2 and UF 5 and is implementing the preventive archaeological programs in UF 1, UF 3 an UF 4. Also developed laboratory activities and training activities about the importance of the archaeological heritage.</p> <p>The concessionaire has its own laboratory and is working on identifying a place to deliver all the archaeological findings, also is working on the characterization and management plan of the Petroglyph in UF 5 and Cafetales area in UF 3.2.</p>

Figure 5 Petroglyph finding in UF 5

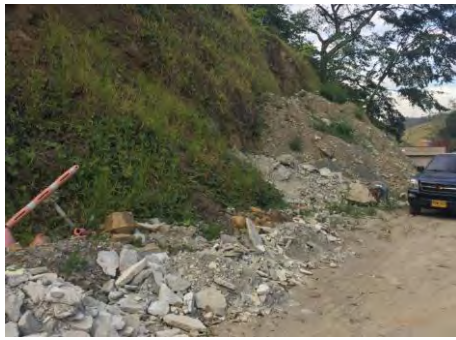
Figure 7. Debris and excavation material in different places than the authorized.

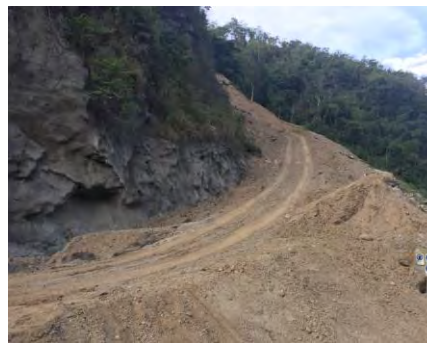
4	<p>Entrance portal of Irra Tunnel:</p> <p>Between November 2017 and January 2018, one segment of the entrance portal of the Irra Tunnel collapsed (K52+300) due to a translational landslide. Currently, the Concessionaire is working in the stabilization of this sector though the implementation of different mitigation and control measures. As requested in the last monitoring</p>	<p>Biannual – Next Envi. And social report.</p>	<p>The Concessionaire should inform Arup of any notification or visits of the environmental authorities, ANLA and Corpocaldas. In addition, it should present the reports or documents showing the final works in this sector and should install a life line until the stabilization activities reaches an end.</p>

Figure 8 High slopes in Irra Tunnel, lifeline recommended.

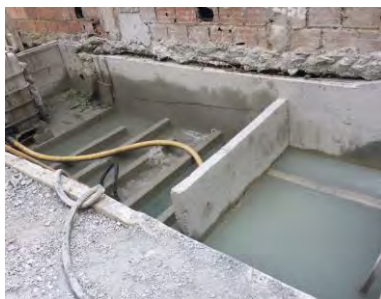
No.	Proposed Action (As set in the ESDD or previous Action Plan)	Proposed Deadline	Current Status (Updated December 2018)	Color code
1	<p>Risk of fall at Tesalia Tunnel : The channel to conduct the water from inside the tunnel to the its entrance, is not well signaled and does not have any protection barrier. This could represent a risk of fall for employees and machinery.</p> <p>Consecutively, Arup request he installation of a protection barrier to the reduce the risk of fall.</p> <p>Furthermore, during the evaluated period 3 accidents were reported in Tesalia Tunnel’s gallery portal, the Concessionaire manage the events according to the approved procedures, even though Arup request the Concessionaire to implement all the preventive measurements in order to prevent more accidents related to the Patia fault.</p> <p>UF: 2.2 PS4</p>	Immediately	As seen in the past monitoring period the Concessionaire has not installed a protection barrier to reduce the risk of fall at the industrial wastewater treatment plant in Tesalia Tunnel. This action is still marked as Pending.

Figure 11. WWTP without protection barrier in flocculant section in Tesalia exit portal.

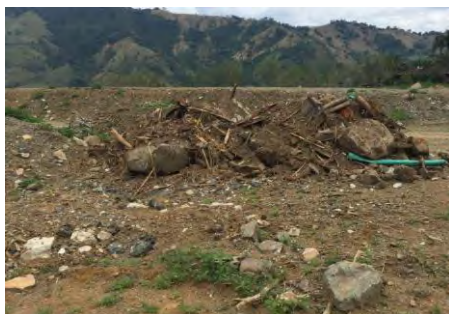
Figure 13. Wood, plastic and debris in ZODMES

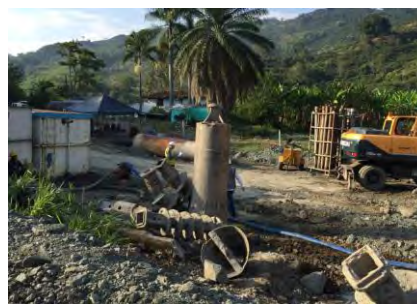
14	Soil protection: The concessionaire has approved the management actions for the protection of soils, one of these measures is related to the protection measures in temporary camps, plants and facilities. During the site visit Arup evidenced that in camp some materials,	Biannual – Next Envi. And social report.	New Action

Figure 14. Cleanliness order and soil protection required.

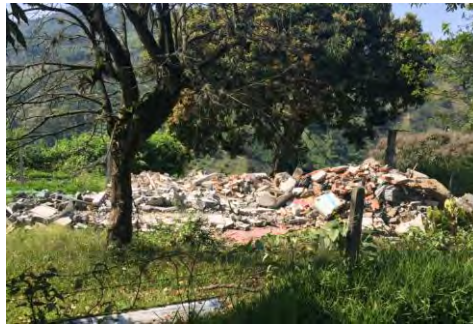
Figure 18. Debris with no management.
