6.5 Action Plan

Table 9 Action Plan Monitoring

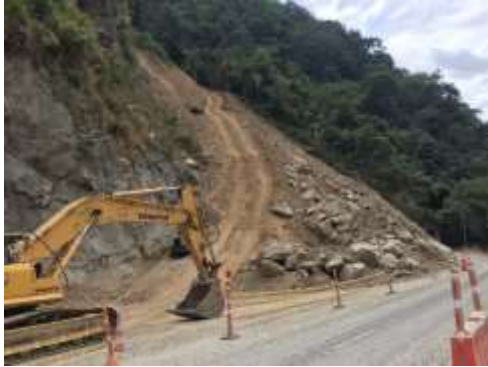
<p>9 Entrance portal of Irra Tunnel: Between November 2017 and January 2018, one segment of the entrance portal of the Irra Tunnel collapsed (K52+300) due to a translational landslide. Currently, the Concessionaire is working in the stabilization of this sector through the implementation of different mitigation and control measures.</p> <p>The landslide occurred outside the allowed area of the Environmental License and PAGA of UF4. However, the Concessionaire is performing mitigation works in order to maintain the road trafficability. The Concessionaire has reported the event to national and regional environmental authorities, ANLA and CORPOCALDAS. Up to the date of this report, the Concessionaire has received a site visit from the ANLA and none site visit from CORPOCALDAS. The Concessionaire has not received any notification or request from additional information from these authorities.</p> <p>During the site visit, it was evidenced that the Concessionaire is progressing with the stabilization measures and is working in line with environment and health and safety standards. Construction activities at the tunnel are suspended until stabilization works are finished.</p>	Biannual – Next Envi. And social report. (January 2018)	New Action The Concessionaire should inform Arup of any notification or visits of the environmental authorities, ANLA and Corpocaldas. In addition, it should present the reports or documents showing the final works in this sector.

Figure 1 Landslide at the entrance portal of Irra Tunnel

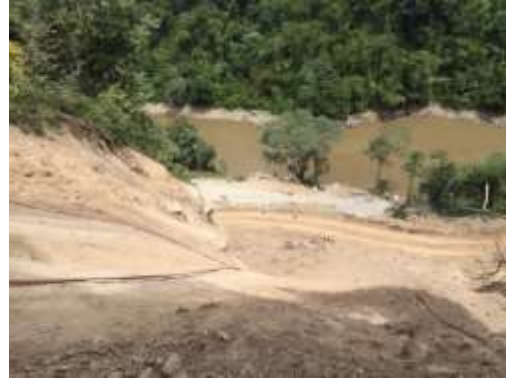
Figure 2 Landslide at the entrance portal of Irra Tunnel from the top.

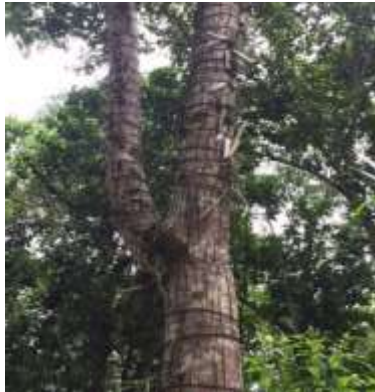
Figure 3 Epiphytes relocation at Guasimo property

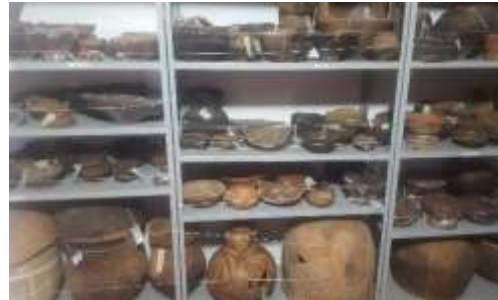
<p>4 Archaeology: According to the results obtained during the archeological field studies phase, which determined that the Project area has an archeological potential qualified as medium-high, and estimated the probability of archeological findings, the area is considered to have a risk of significant findings. UF: All PS/EP:PS8</p>	Biannual – Next Envi. And social report. (January 2018)	The Concessionaire continues with the archeological findings activities at UF3.1, UF3.2 and UF2. They have finished activities at UF4. Up to date, the overall progress is of 80% and they are expecting to end site works by December 2018. Currently, the archeological team has 42 members and they are planning to hire 20 more people. During the site visit, Arup reviewed the archeology laboratory and considers the Concessionaire is doing a rigorous work in the identification and study of all the pieces that have been found.

Figure 4 Archaeology laboratory

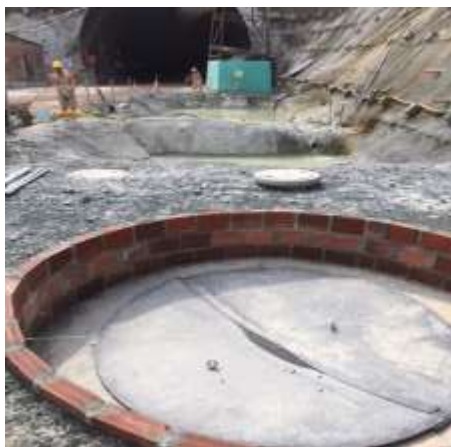
Proposed Action (As set in the ESDD or previous Action Plan)	Proposed Deadline	Current Status (Updated June 2018)	Color code
		whether or not the amount paid is enough to cover the legal requirements for this type of event.	
<p>8 Industrial water management of Tesalia Tunnel: The Concessionaire has started construction activities in both tunnels and has implemented a permanent primary treatment, which currently is capable to attend the infiltration flow. However, the water conduction from inside the tunnel to the treatment system could be improved. Specifically, in the entrance portal of Tesalia Tunnel, there is a lot of stagnant water (Figure 8).</p> <p>UF2 PS3</p>	Immediately	The Concessionaire has significantly improved the industrial wastewater treatment at the entrance and exit portal of Tesalia tunnel. Visually, it can be said that the treatment is efficient and is cleaning a high percent of the suspended solids. In addition, at the entrance portal, the Concessionaire has an inhouse laboratory, where they are performing daily measures of water quality parameters.

Figure 5 Sedimentation ponds at Tesalia tunnel – entrance portal

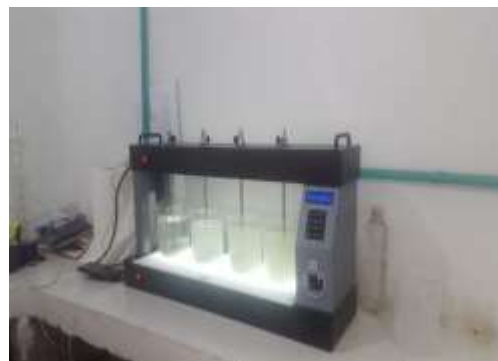
Figure 6 Industrial water treatment laboratory at Tesalia tunnel – entrance portal

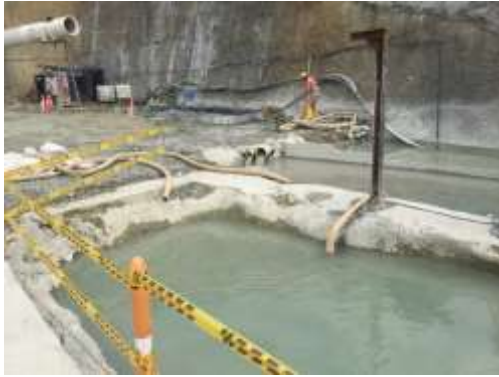
Figure 7 Sedimentation ponds at Tesalia tunnel – exit portal

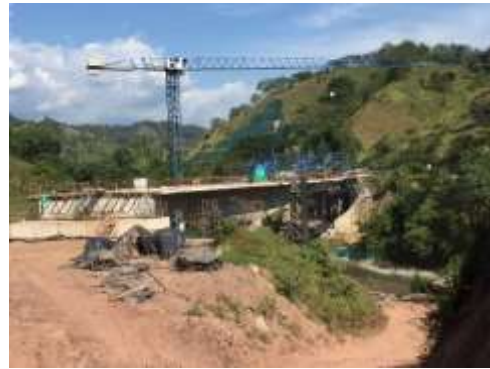
Figure 8 Bridge workfront
